INDOOR AIR QUALITY ASSESSMENT

**Salemwood Elementary School
529 Salem Street
Malden, Massachusetts**

Prepared by:
Massachusetts Department of Public Health
Bureau of Environmental Health Assessment
September, 2000

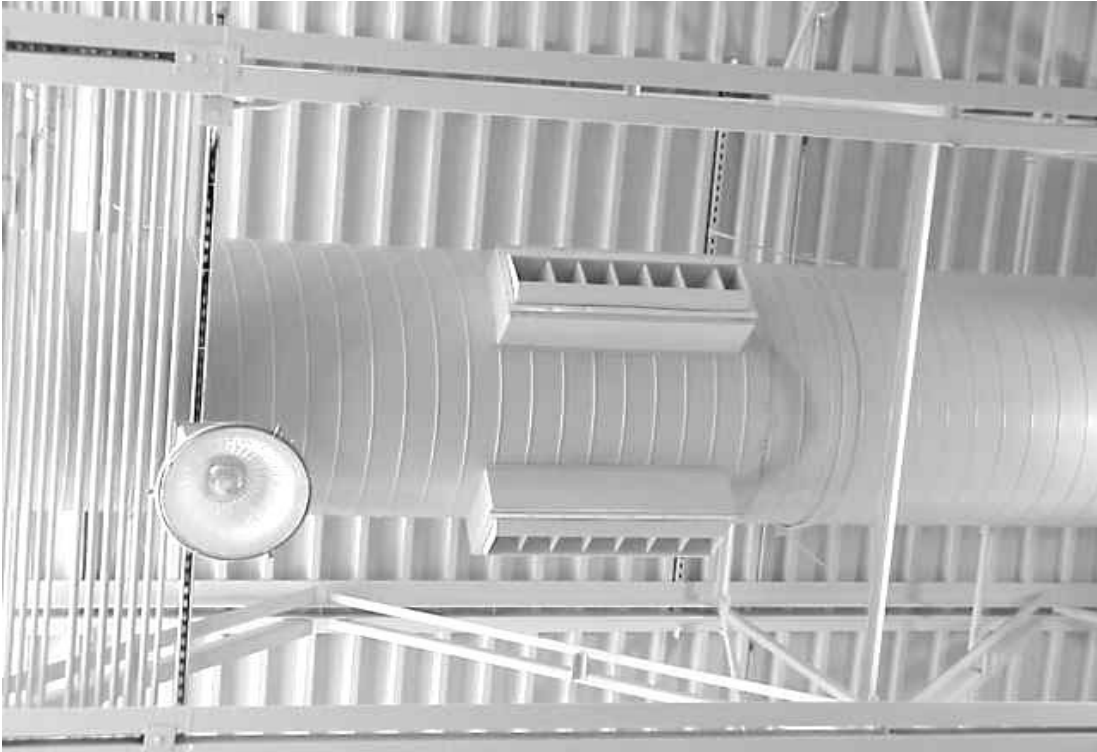
2. Picture 1

Gymnasium Fresh Air Supply Vents

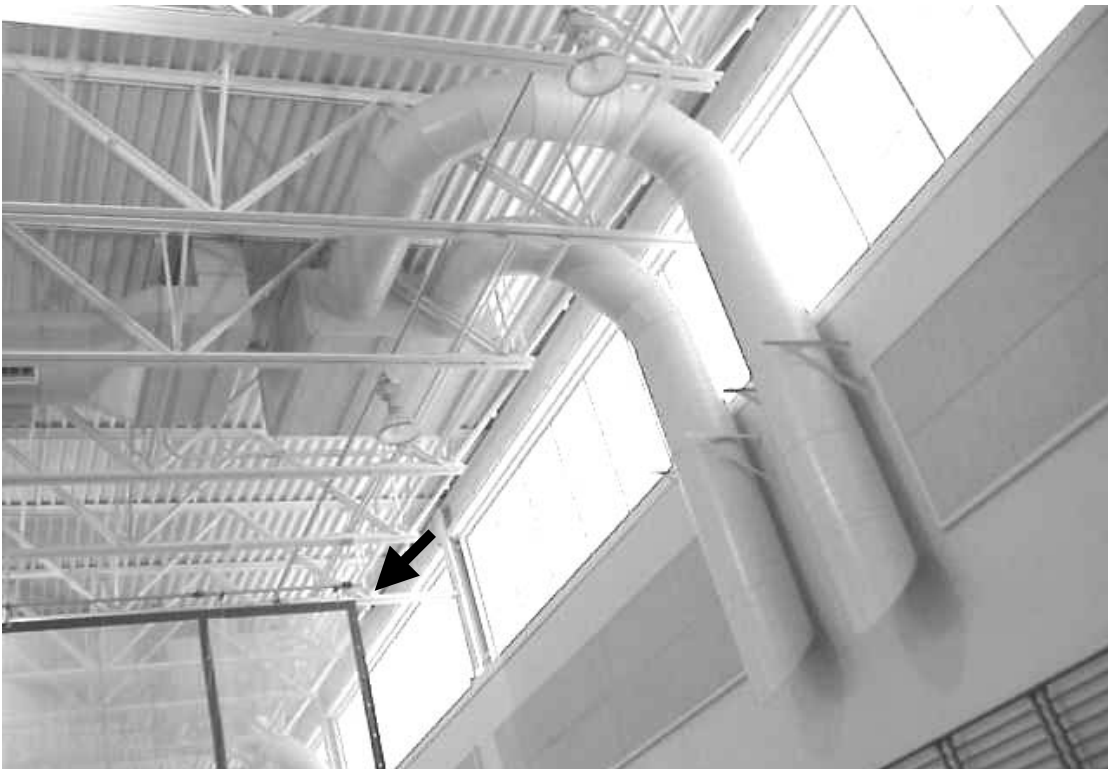
Picture 2

TVOC readings within the gymnasium were found to be equal to or below levels measured outdoors in all occupied areas surveyed. While these results suggest that no interior source is creating a build up of pollutants, there was a slightly pungent odor noted in the gym area. The odor was described by several building occupants as a “new shower curtain” type odor, which was believed to be from hanging dividers used to section off the gym (see Picture 2). No measurable levels of TVOCs were recorded in the area of this material.

Gymnasium Exhaust Vents Note Hanging Gym Divider at Left

3. Continue to operate gymnasium ventilation system to remove odors associated with vinyl dividers.
4. For buildings in New England, periods of low relative humidity during the winter are often unavoidable. Therefore, scrupulous cleaning practices should be adopted to minimize common indoor air contaminants whose irritant effects can be enhanced when the relative humidity is low. To control for dusts, a HEPA filter equipped vacuum cleaner in conjunction with wet wiping of all surfaces is recommended. Drinking water during the day can help ease some symptoms associated with a dry environment (throat and sinus irritations).

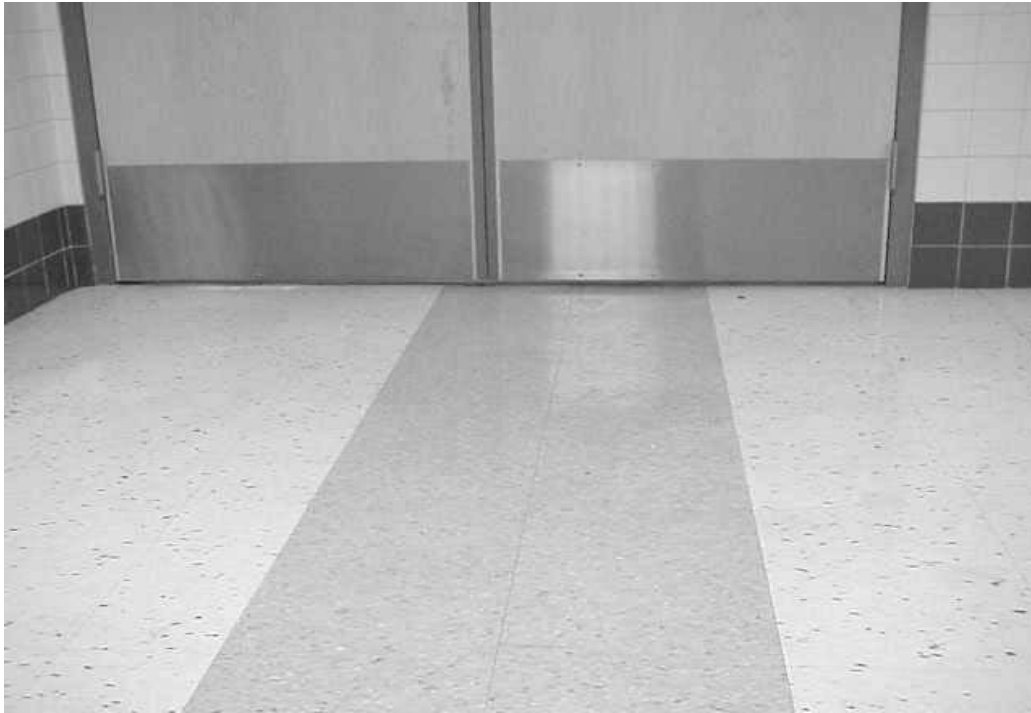
Picture 3

A number of other conditions were noted during the assessment, which can affect indoor air quality. A space was noted beneath the boiler room door (see Picture 3). Air currents created by temperature and pressure differentials can allow particulates/odors to migrate into adjacent areas of the school through this space. The school's boilers were not operating at the time of the visit and no odors were detected during the assessment.

Space under Boiler Room Doors

6. Install weather-stripping on bottom of boiler room door to prevent the migration of odors/particulates into occupied areas.

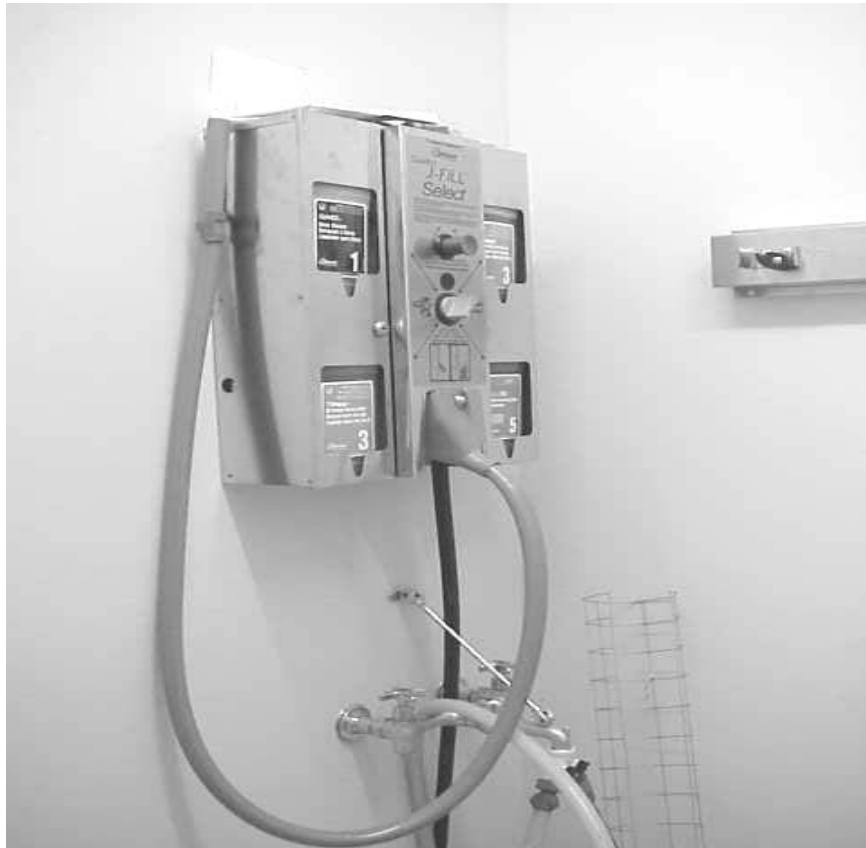
3. Picture 4

Concerns regarding the storage conditions of janitorial cleaning supplies were expressed. BEHA examined a number of janitorial closets and found them to be clean and well organized. Typical cleaning agents are dispensed in a pre-measured amount by a self-contained wall-mounted unit (see Picture 4). This method eliminates waste, spillage and misuse. TVOC readings in these areas were found to be equal to or below levels measured outdoors.

Example of Self-Contained Cleaning Solution Station in Custodial Closet

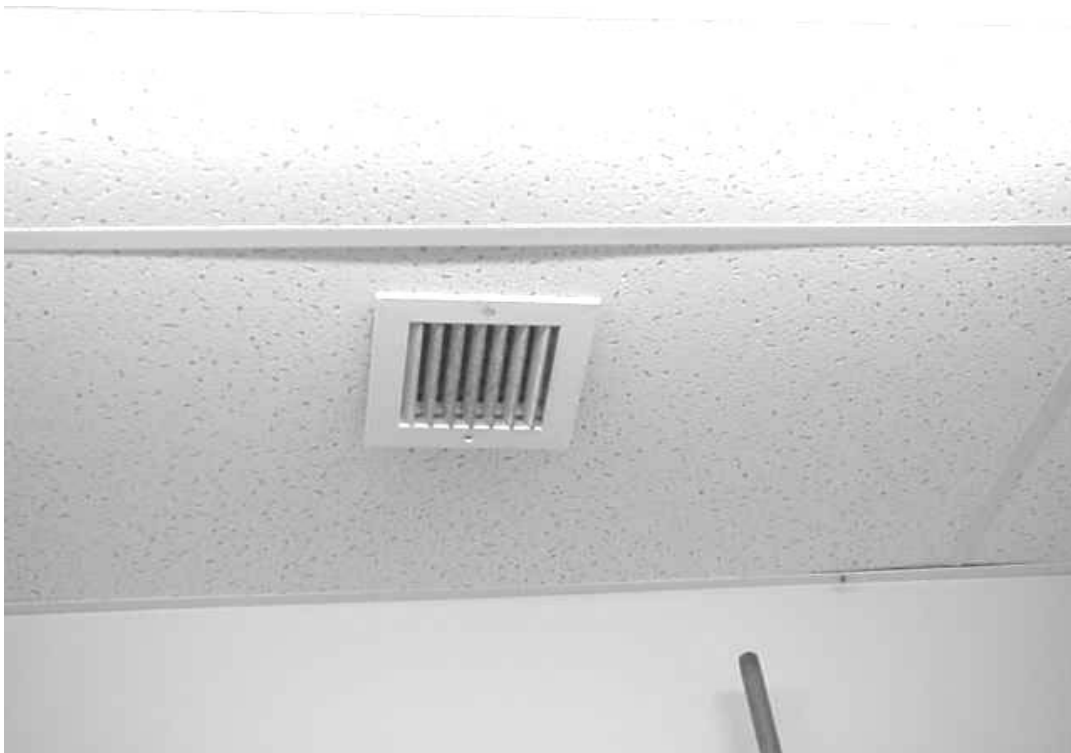
4. Picture 5

Example of Ceiling-Mounted Local Exhaust Vent in Custodial Closet

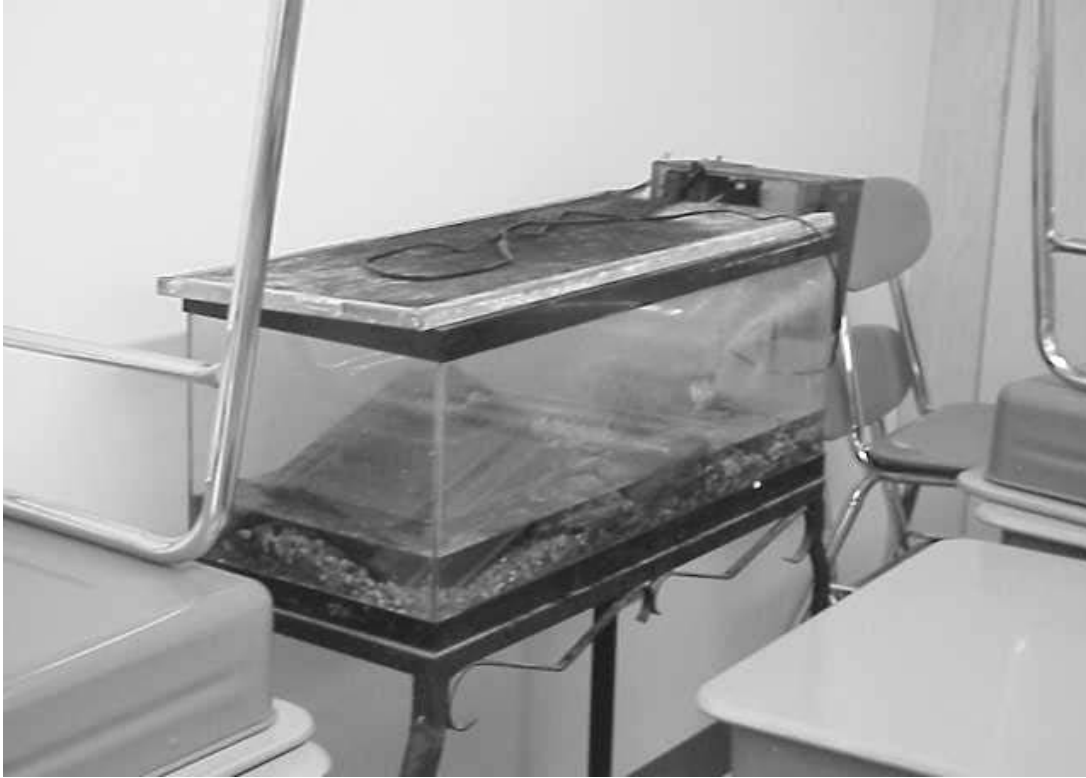
Picture 6

Several stained ceiling tiles were also noted in classrooms, which can indicate leaks from either the roof or plumbing system. Water-damaged ceiling tiles can provide a source for mold growth and should be replaced after a water leak is discovered. Classroom C-309 had an abandoned aquarium containing standing water that appeared to be white and cloudy with mold/algae growth (see Picture 6). Aquariums, if not in use, should be properly emptied and cleaned to prevent mold/bacterial growth and/or unpleasant odors.

Aquarium in Classroom C-309 with Standing Water

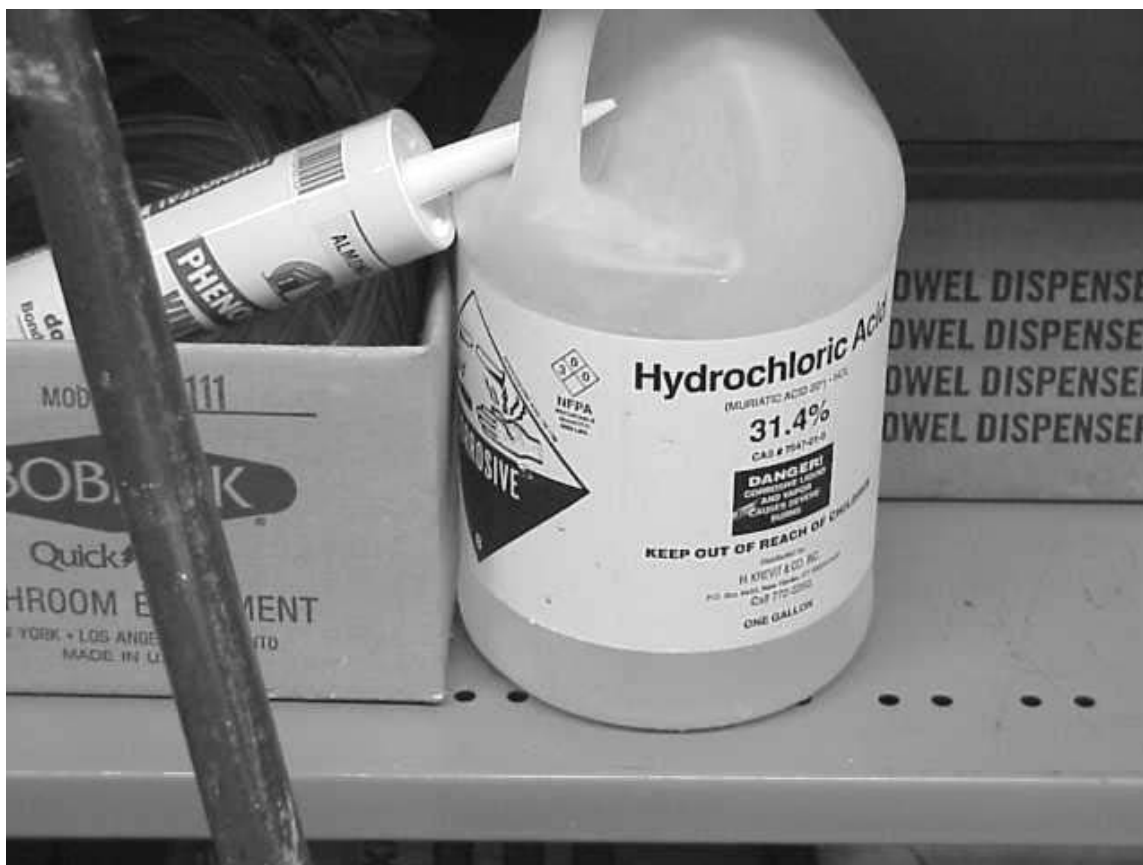
5. Picture 7

The janitorial supply room (A-117) on the first floor contained a number of 1-gallon containers of hydrochloric acid (see Picture 7). All containers were sealed and no odors were noted. According to school staff these containers belong to the general contractor and were being stored in the locked supply area temporarily.

1-Gallon Container of Hydrochloric Acid in Janitorial Supply Room A-117

7. Repair roof/plumbing leaks. Replace any remaining water-stained ceiling tiles and pipe insulation. Examine the area above and around these areas for mold growth. Disinfect areas of water leaks with an appropriate antimicrobial.
8. Change filters for air handling equipment as per the manufacturer's instructions or more frequently if needed.
9. Clean and maintain aquariums to prevent mold/algae growth and associated odors. If not in use empty and disinfect using an appropriate antimicrobial.
10. If hydrochloric acid is stored in the supply room for an extended period of time, consider obtaining an acid storage cabinet.
